**SAS Superstructure**

**Daily Diary Report by Bid Item**

Contract No.: 04-0120F4

Diary #: 607 Const Calendar Day: 21 Date: 25-Jun-2012 Monday

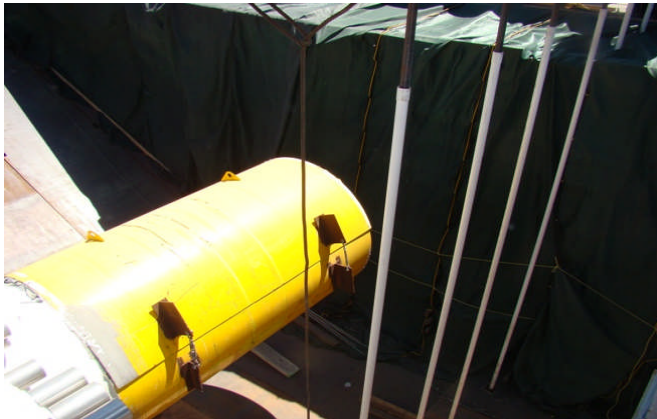
The protective cover placed over the face of the W-Line Hinge K matchcast face for sandblasting the joint.

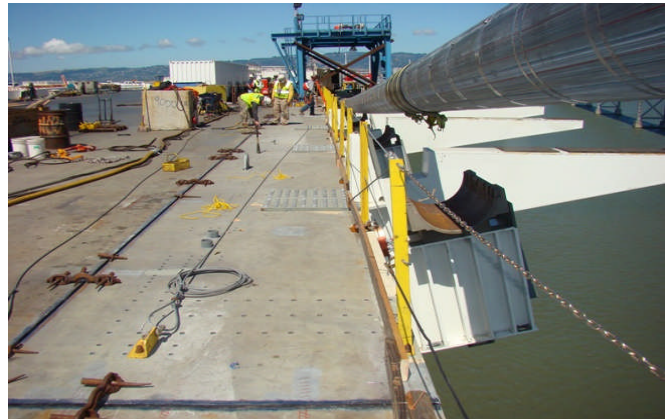
Section of OBG lift 12E that was placed after the swingout operations of the South Mainspan cable were completed.

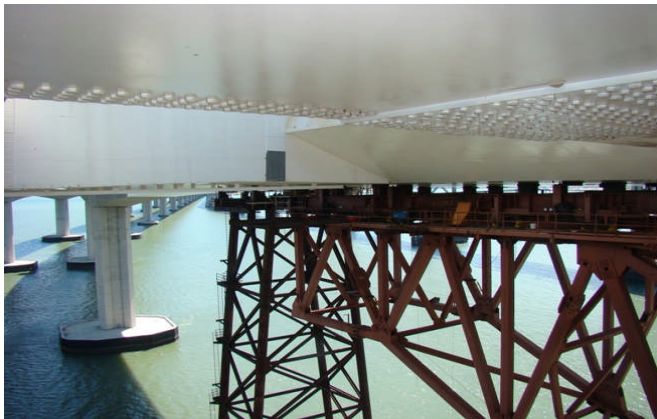
The support cradle is still in place under OBG lift 14E.

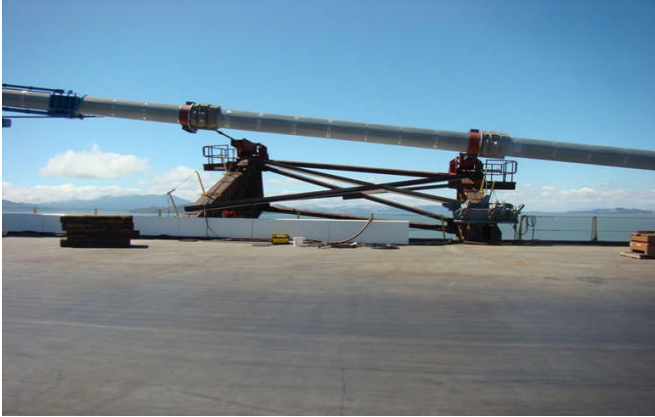
The North Mainspan cable swing out support frame looking north.

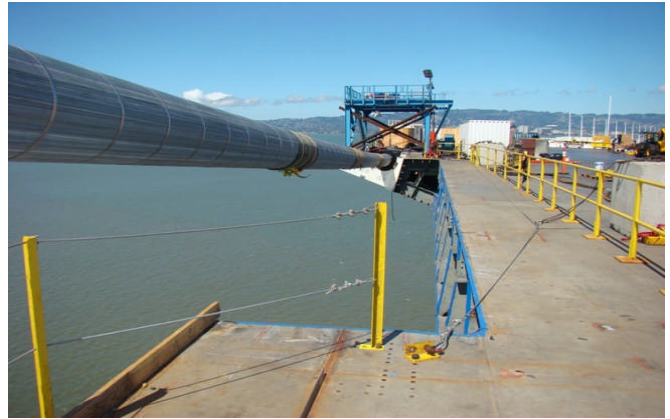
The missing deck section of OBG lift 12W that was left out to facilitate the free hang geometry of the North Mainspan cable.

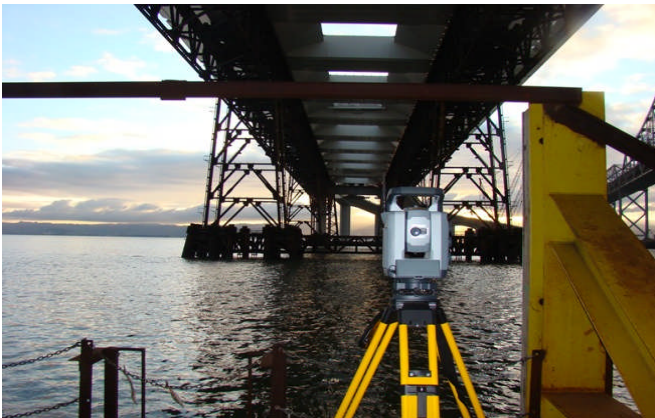
Unofficially both the cap beam and OBG moved together 3" to the east from start to finish, and the movement at the second reading was approximately 1" to the east.

Trimble S8 total station occupying TD2001 on the T1 foundation taking shots on the E2 cap beam and the OBG at sunrise.

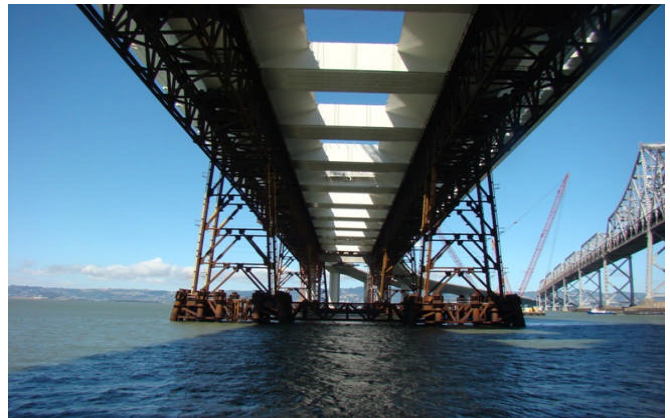
Conditions observed during the fourth and final shot on the E2 cap beam and OBG lift 13E/W.

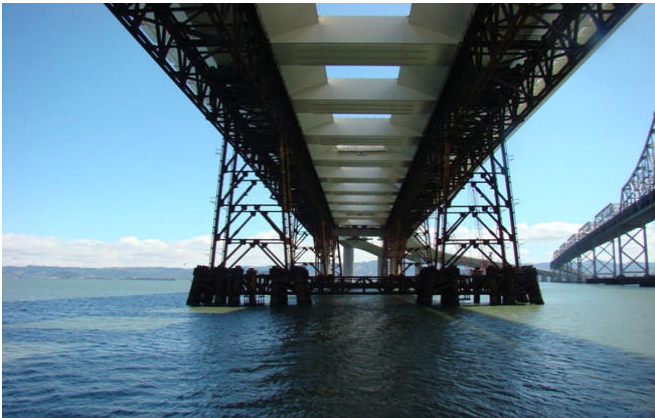
Conditions observed during the second shot on the E2 cap beam and OBG lift 13E/W.

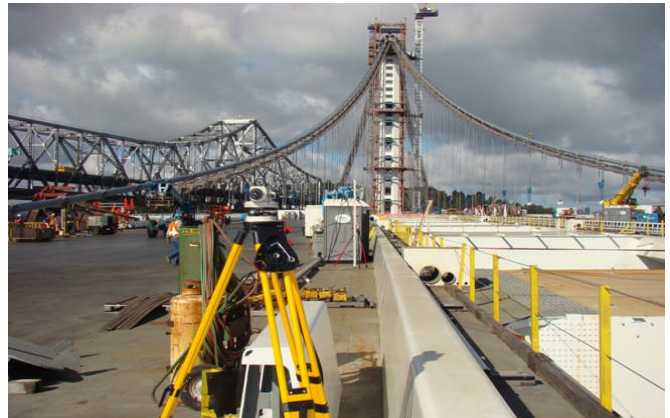
I conducted the survey independently as the bipod was used to support the Philly rod. The level run was done again since the last level run on Friday didn't close within an acceptable tolerance.

Conditions observed during the level run on OBG punchmarks located over the E2 cap beam.
